Publication date	20/07/2015
Document nr.	SUPAIR_2015/07_001
Number of page	1 / 5

SAFETY NOTE

TOPIC : Unusual wear on leg strap.

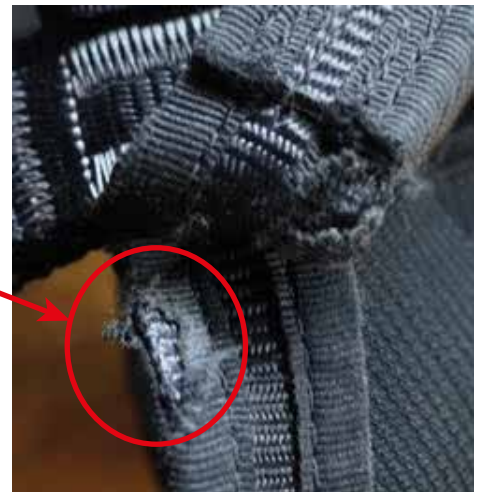
Premature wear and tear on the leg strap can appear and compromise harness security.

Premature wear and tear can be detected on the leg straps.

Signs of wear and tear appear in two stages : firstly on the edging, secondly, after some time, on the webbing itself.

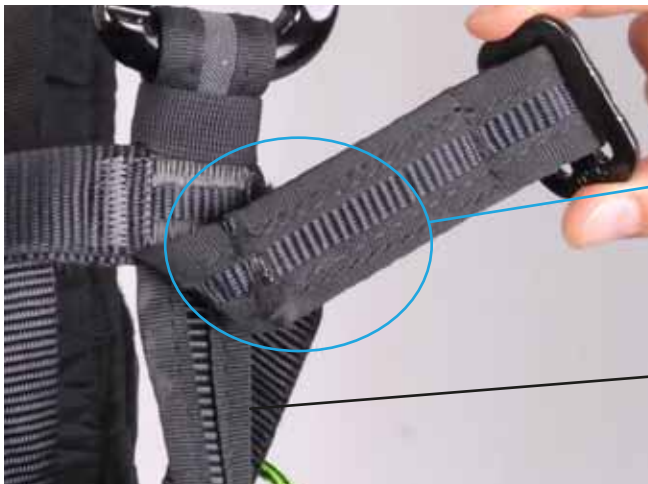
1

The purpose of repair is to protect the structural strap from the wear caused by the end of the "webbing return" (blue circle).
