Date	May 20th 2013
Object	Safety Warning 2013/04 WALIBI LITE, WALIBI ² , EVASION ²

Replacing reserve parachute pocket elasicated cords

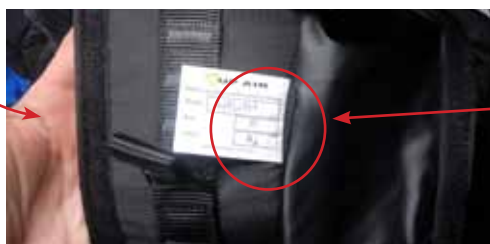
Label location

The code is found on the sewn label located under the right shoulder flap reserve parachute connection point.
