## EVO LITE INFORMATION

## January 8th, 2021

Harnesses concerned: EVOLITE index A1 to A9

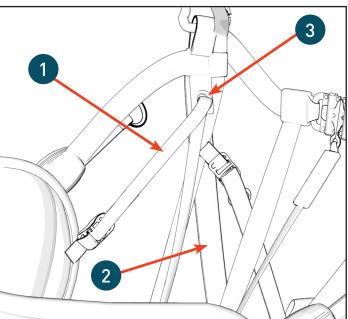
Eyelet

The eyelet that serves as a deflection point for the lumbar comfort/seat depth adjustment can damage the strap. This is mainly due to a very tight adjustment that takes up all of the pilot's weight on this adjustment strap.

We recommend that you take care to adjust the seat depth within the limit of keeping the main strap under tension.

The main strap should be under tension even after adjusting the setting.
