<b>Published date</b>	30/01/2019
<b>Document number</b>	SUPAIR_2019/01//001
<b>Page number</b>	1 / 2

## Product lifespan / usage advice

### ALTIRANDO 3

### EVOLITE

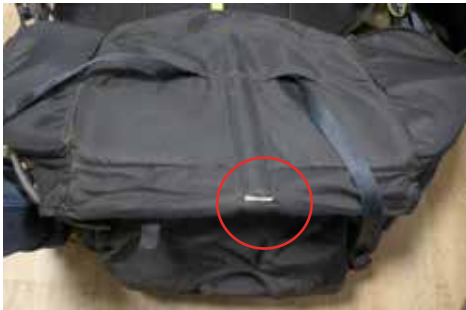
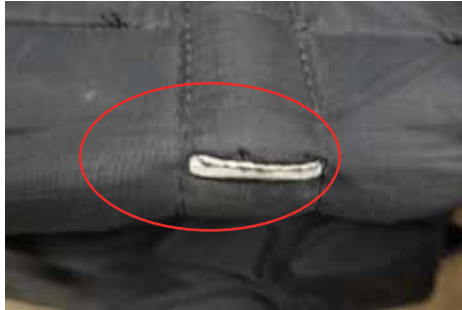
#### Risk of premature wear :

The fiberglass batten located beneath the seat may, in some instances, pierce the fabric.

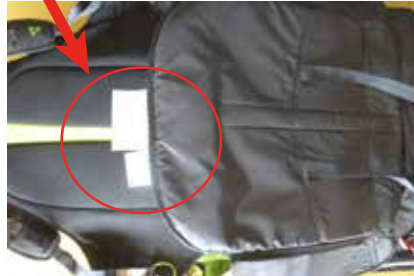
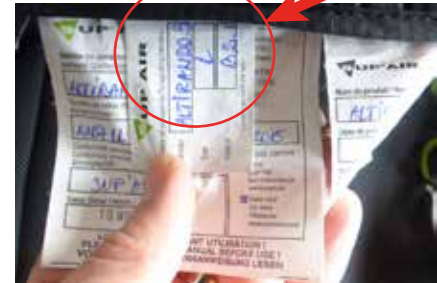
##### Harness ALTIRANDO 3

Index B2 to C1

Version C1.1 has been modified and does not pose a problem anymore.

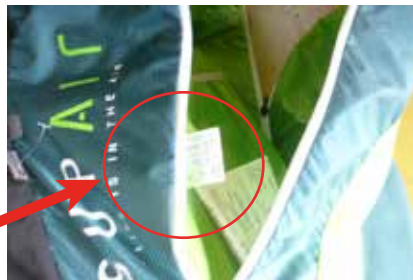
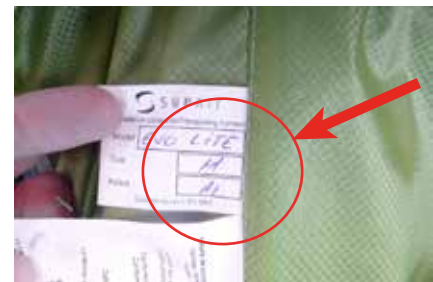
##### Harness EVOLITE

Index A1 à A8.

Version A8.1 has been modified and does not pose a problem anymore.

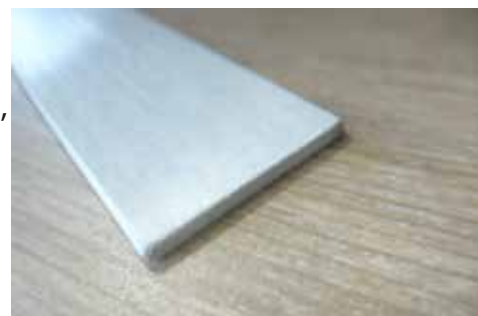
The batten was placed inside its sleeve without protection, thus exposing one end with sharp edges.
