| Document number | SUPAIR_2019_10_001 |

SAFETY WARNING

SUBJECT : ALTIRANDO Lite
Parachute pocket

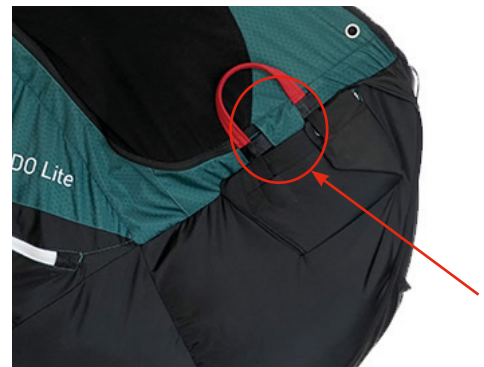
We have identified that, on some ALTIRANDO Lite harnesses, when using certain parachutes (high volume mostly), the magnetic flap used to fasten the parachute pocket could too easily get out of its socket.

The handle can therefore break lose and the parachute pocket may inopportunately open.

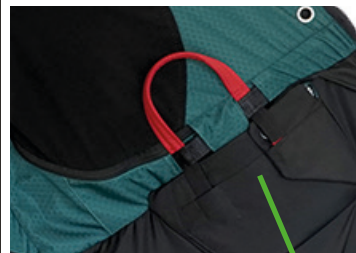
A : The magnetic flap regularly get out of its socket

Contact SUPAIR (info@supair.com)

To order a flap extension, free of charge. To put it on, slide this piece of fabric directly on the flap (as shown in the pictures below).
