Published date	12/07/2021
Document number	SUPAIR_2021_06_001
Page number	1/2

## SAFETY CHECK REQUEST

**SUBJECT :** WALIBI LITE harnesses manufactured before 2019

Request to check the extraction of the rescue parachute on WALIBI LITE harnesses manufactured before 2019

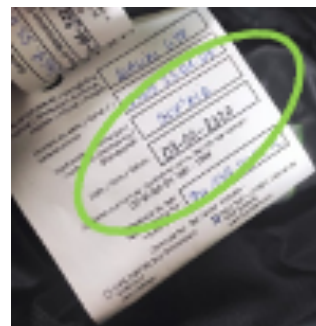
You can find the date of manufacture on the label in the back pocket of the harness.

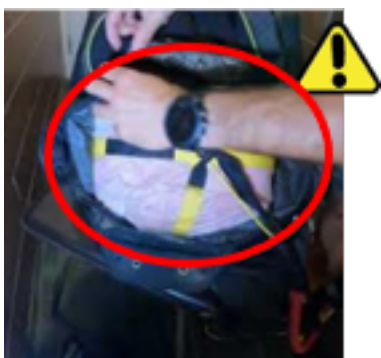
CHECK under a gantry that the rescue parachute can be extracted and that the inside of the parachute pocket does not stick to the rescue parachute.

**The rescue parachute can't be extracted or the inside of the parachute pocket sticks and interferes with the correct extraction of the reserve parachute**

**Contact SUPAIR : [sav@supair.com](mailto:sav@supair.com)**
