Published date	13/02/2019
Document number	SUPAIR_2019/02/001
Page number	1 / 2

SUBJECT : Front reserve container standard

The coating on the rescue parachute container flaps might become sticky.

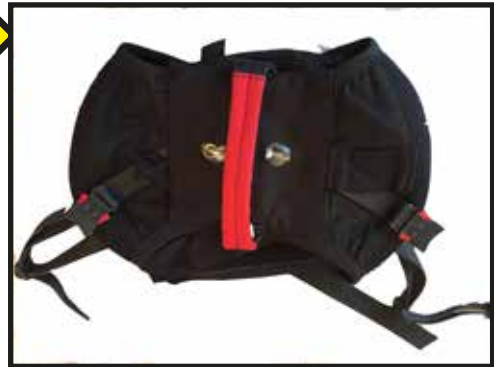
The coating of the black Cordura might deteriorate overtime and become sticky. It is possible that the degraded rescue parachute container flaps affect the parachute extraction, making it harder or even impossible.

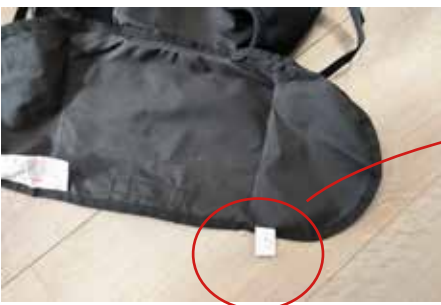
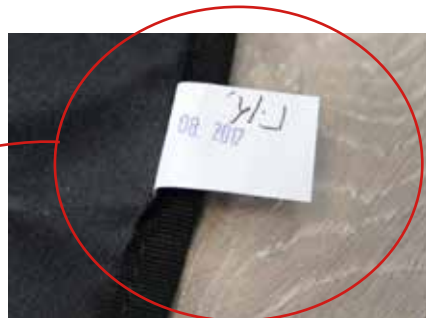
FRONT RESERVE CONTAINER STANDARD

Manufactured between 2007 and 2008

During their yearly parachute extraction test, several pilots noticed that the rescue parachute container flaps had become sticky.

(Fabric defect as regards to the stability of the coating overtime)
