<b>Published date</b>	16/06/2017
<b>Document number</b>	SUPAIR_2017/06_001
<b>Page number</b>	1 / 2

# SAFETY WARNING

## SUBJECT: STRIKE Harness

Tear in leg strap side panels

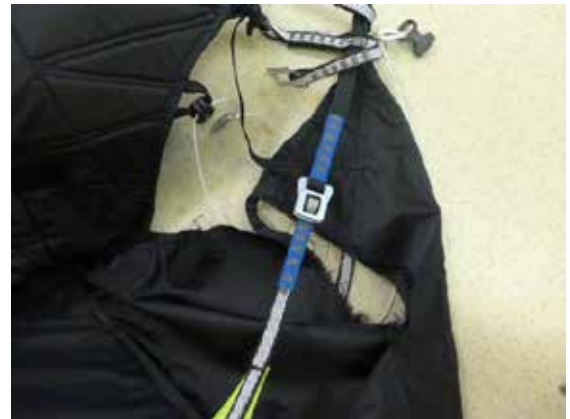
It is possible that tears could appear in the side panels when high G force is applied

Some tears occurred in the side panel during hard spiral dives or other manoeuvres with high G force. The tears do not compromise the structure of the harness but may destabilise the pilot in the harness during and after the manoeuvre and the harness might become uncomfortable to fly.

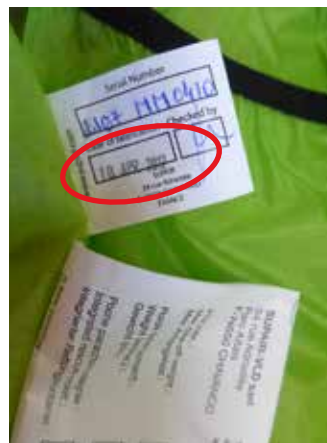
Recto

Open the back storage compartment  
The production index is on the small label
