Harness inspection certificate

Inspection certificate number: PH_233.2018

Harness Structural test Report

Harness Structural test

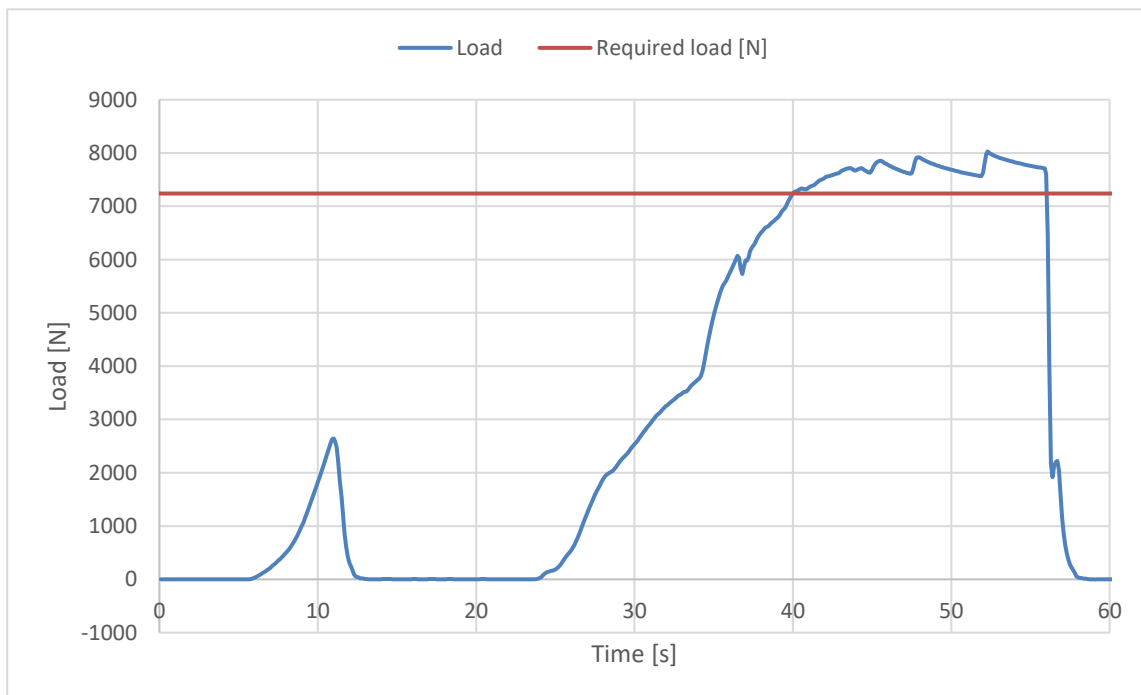
Test ID R0

Standard	EN 1651:1999
Reference in standard	5.3.2.1
Test setup	Default flying position
Attachment points	Both main riser attachment (3,4)
Anchor points	Dummy (B1, B2)
Required load [g]	6
Required load [N]	7200
Minimum test duration [s]	10
Result	
Test duration [s]	16.1
Any signs of structural failure	No
Test results	POSITIVE

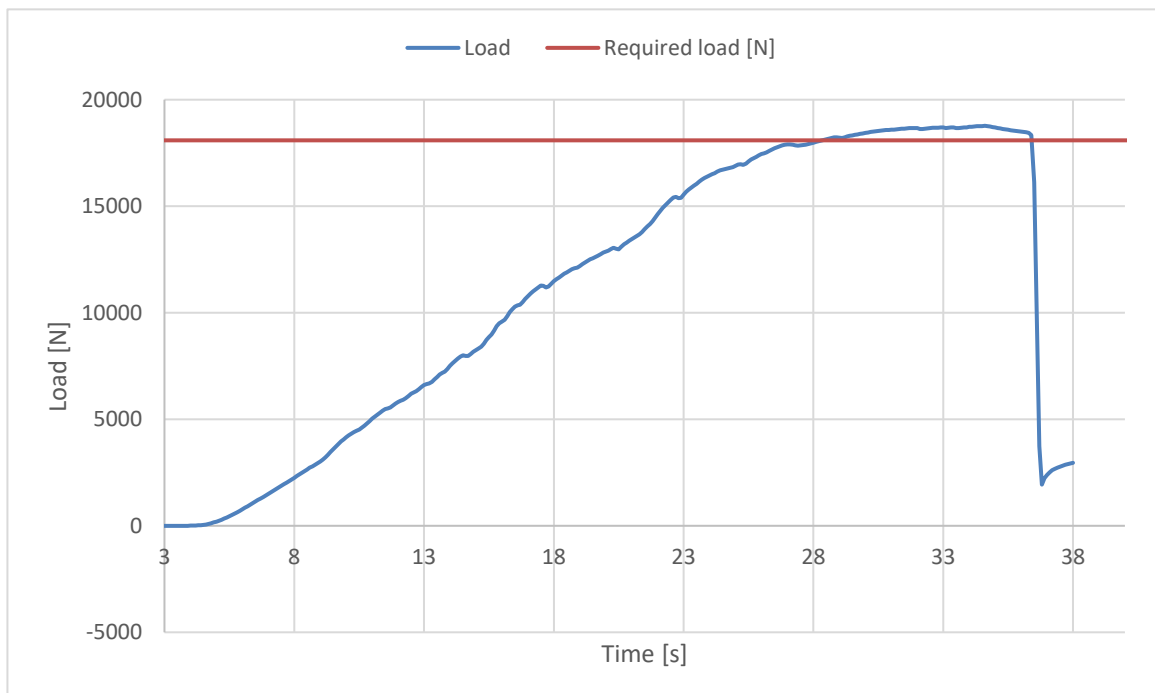
Test ID R2

Reference in standard	5.3.2.2	
Test setup	Default flying position	
Attachment points	Both main riser attachment (3,4)	
Anchor points	Dummy (B1, B2)	
Required load [g]	15	
Required load [N]	18000	
Minimum test duration [s]	5	
Result		
Test duration [s]	8.1	
Any signs of structural failure	No	
Test results	POSITIVE

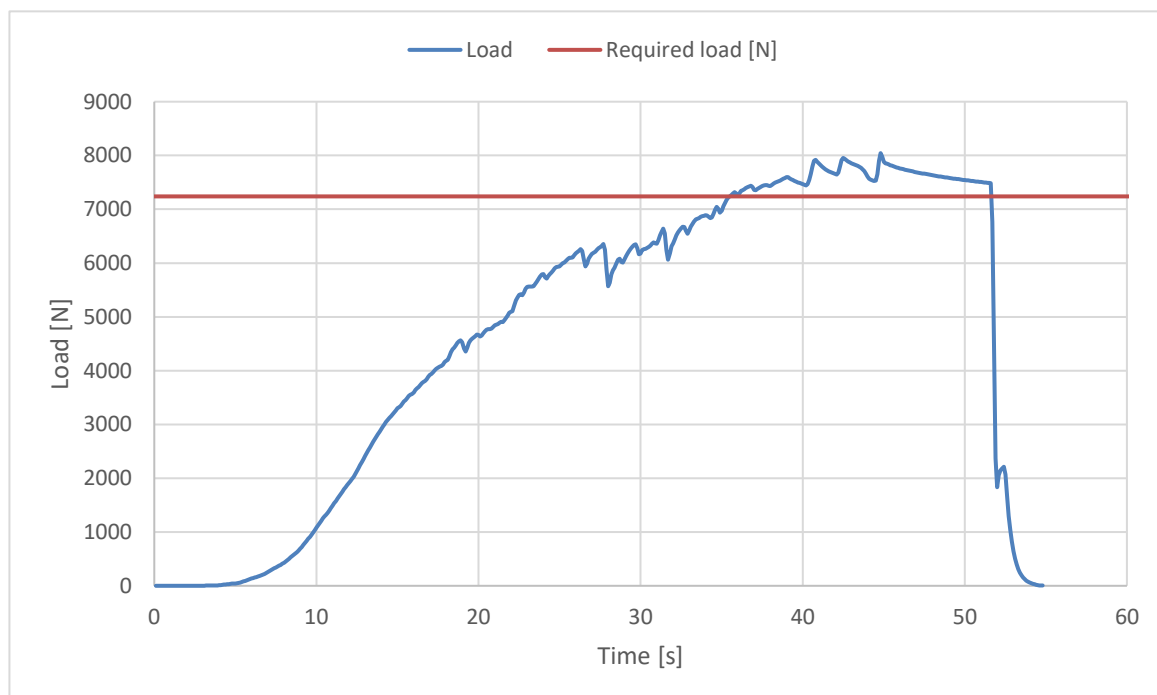
Test ID R8

Standard	EN 1651:1999
Reference in standard	5.3.2.3
Test setup	Asymmetric, one riser
Attachment points	One main riser attachment (3)
Anchor points	Dummy (B1,B2)
Required load [g]	6
Required load [N]	7200
Minimum test duration [s]	10
Result	
Test duration [s]	16.2
Any signs of structural failure	No
Test results	POSITIVE

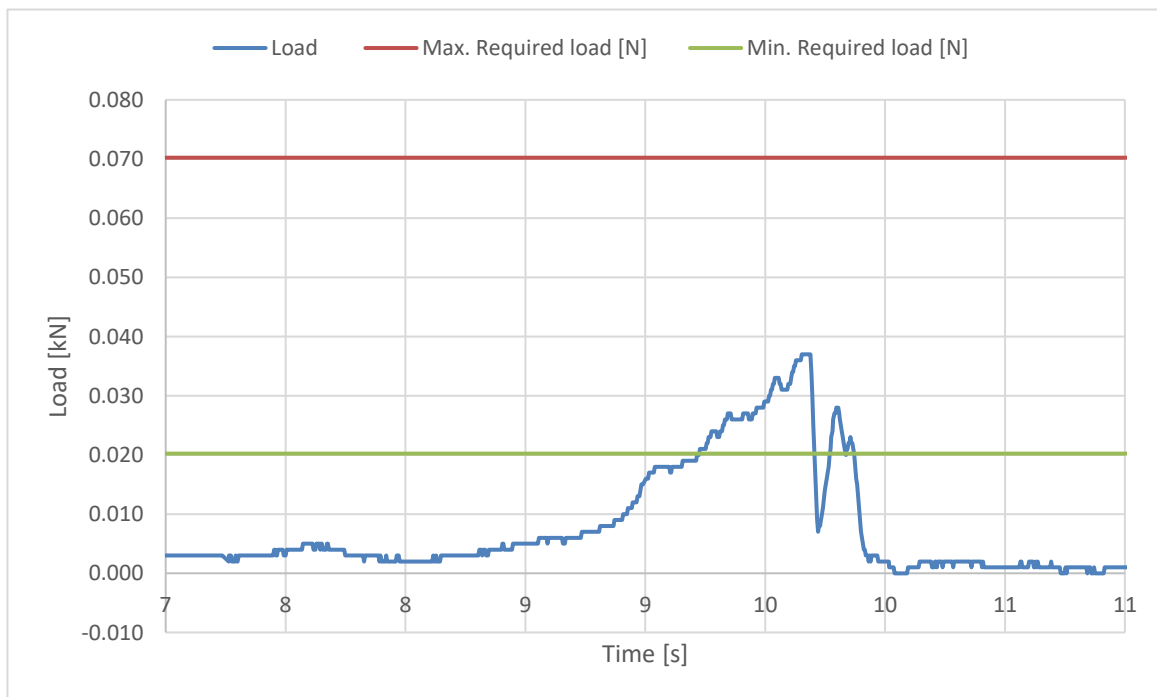
Test ID RRDT

Standard	LTF NfL II 91/09
Reference in standard	6.1.5
Test setup	Default flying position
Attachment points	Sensor connect to handle, and pull in opening direction
	The test is to simulate the load required to open the emergency parachute(1st action).
Min. Required load [N]	20
Max. Required load [N]	70
Result	
Load for first action [N]	36.78
Test results	POSITIVE
