Publication date	20/07/2015
Document nr.	SUPAIR_2015/07_001
Number of page	1 / 5

SAFETY NOTE

TOPIC : Unusual wear on leg strap.

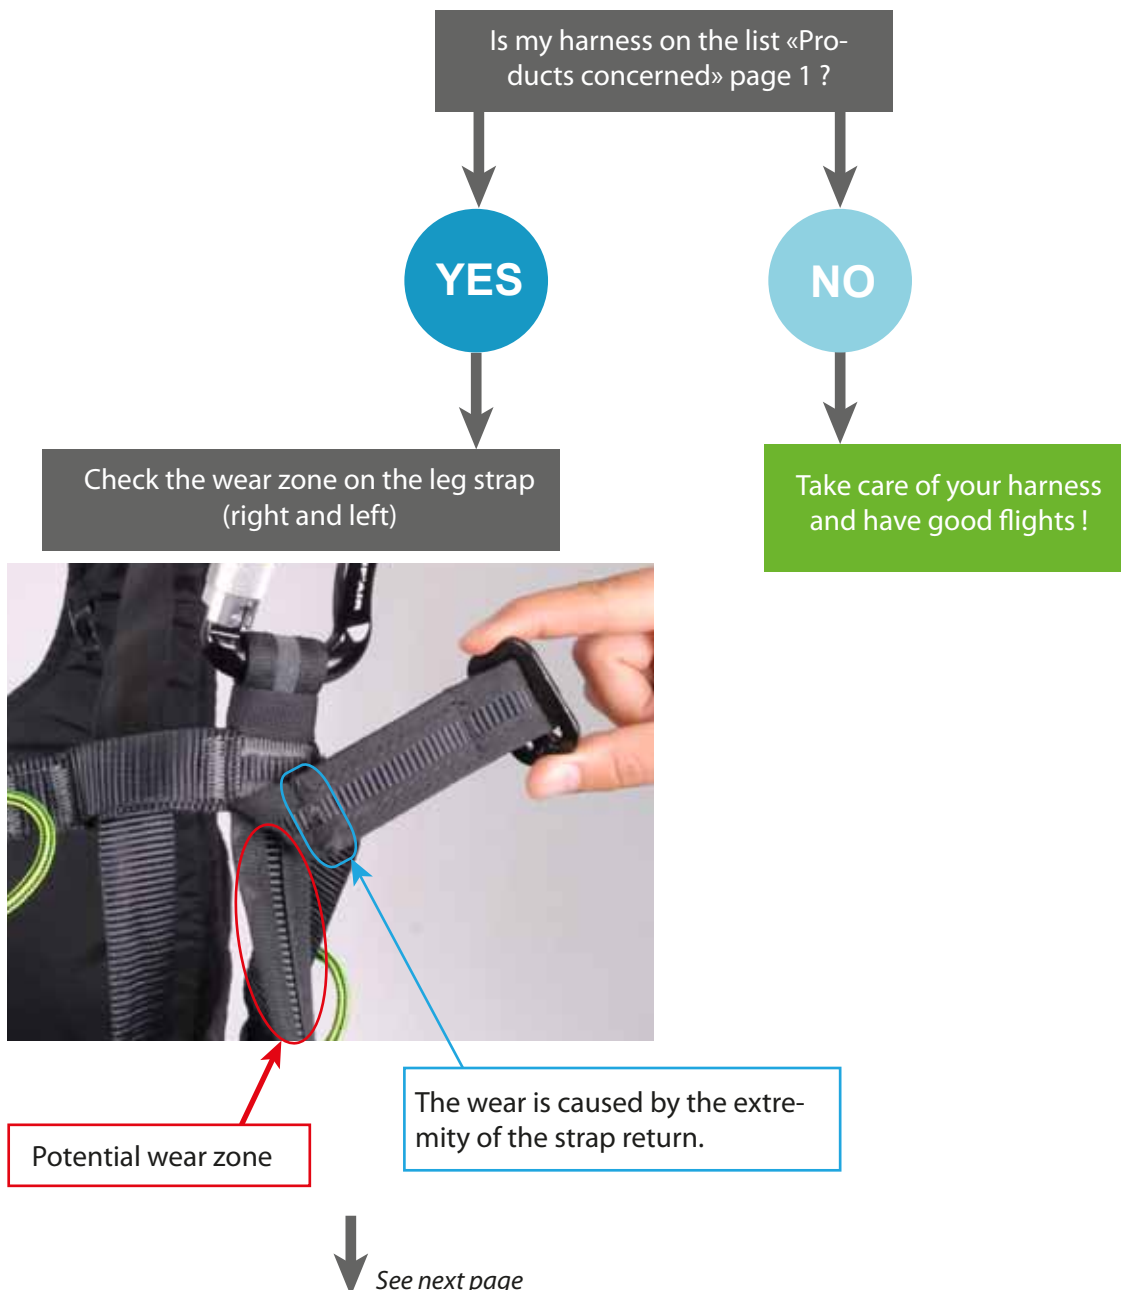
How to know if my harness is concerned ?

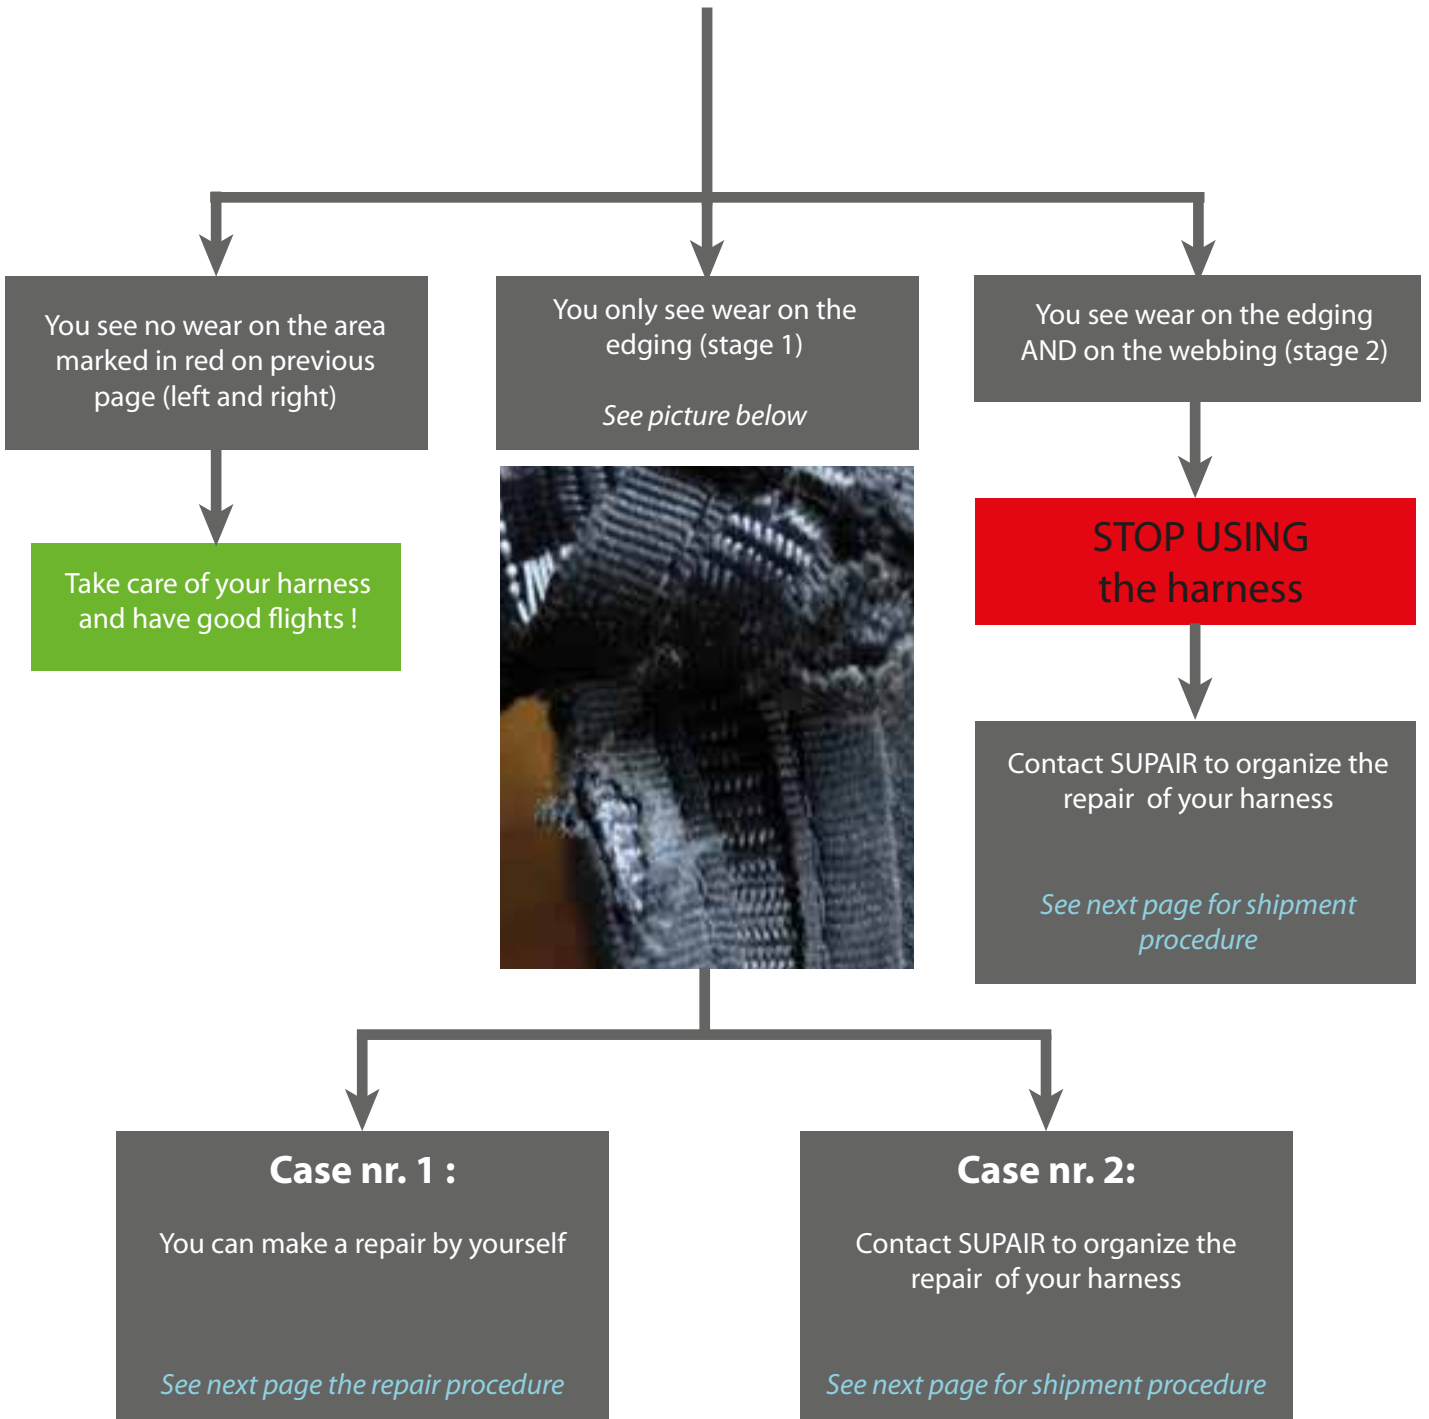
Premature wear and tear can be detected on the leg straps.

Signs of wear and tear appear in two stages : firstly on the edging, secondly, after some time, on the webbing itself.

The purpose of repair is to protect the structural strap from the wear caused by the end of the "webbing return" (blue circle).

To make the protection, you have to roll a piece of thin webbing around the end of the leg «strap return». Sew the system to secure the repair.
