## EVO LITE INFORMATION

## January 8th, 2021

Harnesses concerned: EVOLITE index A1 to A9

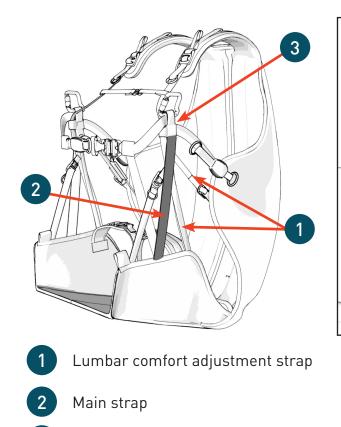
The eyelet that serves as a deflection point for the lumbar comfort/seat depth adjustment can damage the strap. This is mainly due to a very tight adjustment that takes up all of the pilot's weight on this adjustment strap.

Eyelet

We recommend that you take care to adjust the seat depth within the limit of keeping the main strap under tension.

The main strap should be under tension even after adjusting the setting.
